APOLLO 16

COMMAND MODULE CASPER PRIMARY ACCESS HATCH
PURGE PORT DECAL

This research document details the authenticating factors, history, and relevance of the Apollo 16 Command Module primary access hatch Purge Port decal.

APOLLO 16 COMMAND MODULE CASPER
PRIMARY ACCESS HATCH PURGE PORT
DECAL RESEARCH REPORT

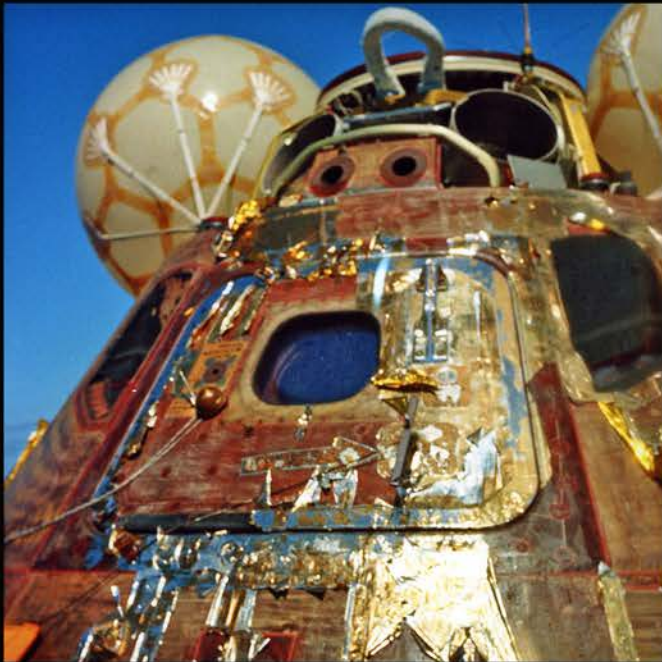
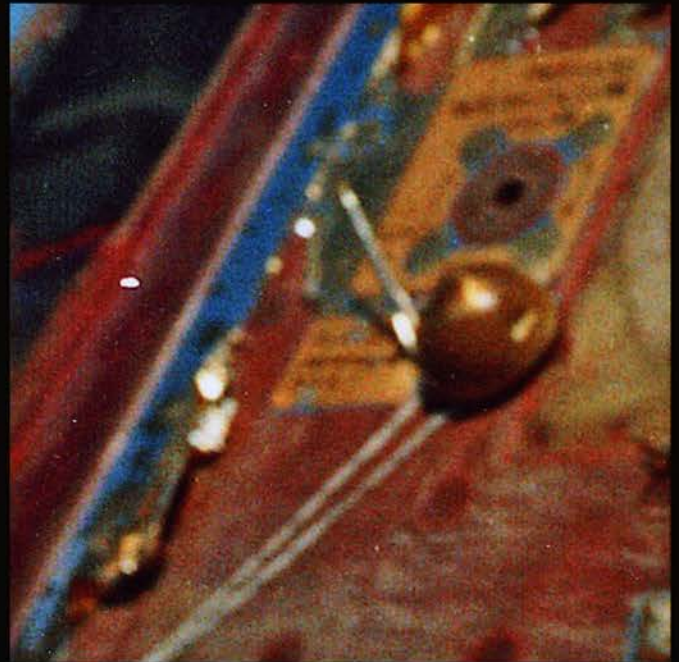
1.1. (Left) Apollo 16 Command Module Casper aboard the USS Ticonderoga recovery vessel during recovery operations. (Right) Close-up view of the Purge Port decal from the same shot.

Photographs taken during recovery operations by the recovery and support crews aboard the USS Ticonderoga were used as a basis for comparison, with a particular focus on re-entry scorch marks and taking into account any damage from removal as well as expected age and wear.

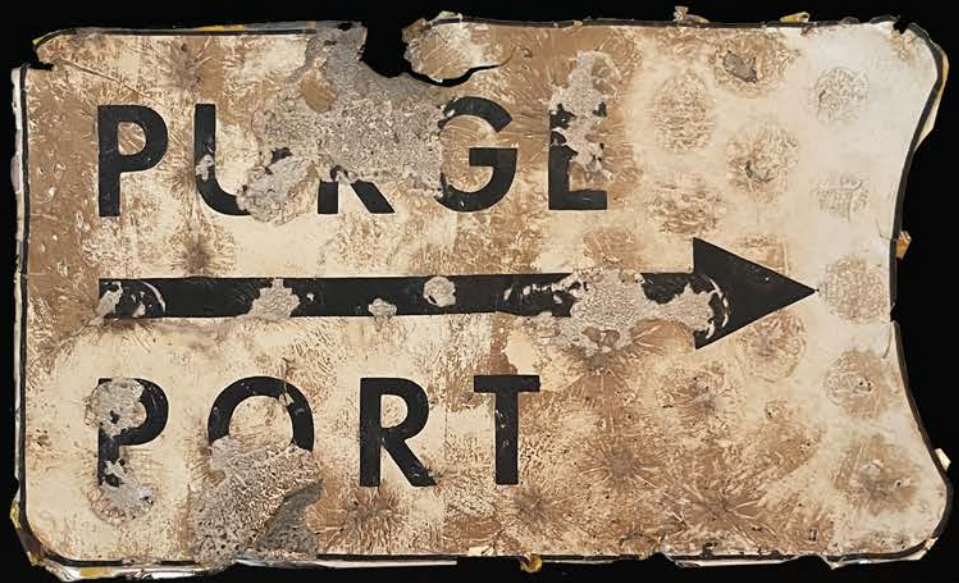
1.2. (Right) Apollo Purge Port decal as it appears today.

As compared to the mission photograph above, the decal scorch marks, honeycomb pattern, lettering and visible kapton foil underlayer match precisely with the decal as it exists today.

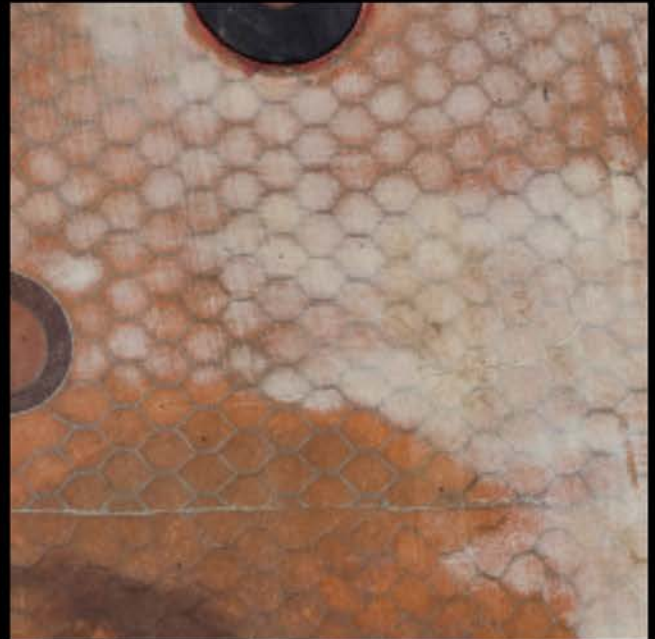
2.1. *(Right) Close-up view of the Apollo 11 Command Module hatch door detailing the heatshield hexagonal honeycomb pattern. This pattern was consistent across all Command Modules.*

Image courtesy of the Smithsonian National Air & Space Museum, Washington D.C.

The Apollo Command Modules were coated in an ablative heat shield structure that was composed of a fiberglass honeycomb, integrated with a phenolic resin and bonded with an epoxy-based adhesive to a cleaned, stainless steel shell. This role was performed by North American Aviation [1]. The heat shield was designed to withstand temperatures in excess of 3200°C. Each Command Module was protected by approximately 370,000 manually-filled honeycomb cells.

A primary characteristic of this heat shield structure was its distinct hexagonal honeycomb pattern.

Measurements provided by the National Air & Space Museum in Washington DC conclude that the honeycomb cells on the Command Module hatch doors measure between 9.53mm to 12.7mm. Measurements taken from the residual honeycomb pattern prevalent on the Purge Port label are consistent with these measurements.

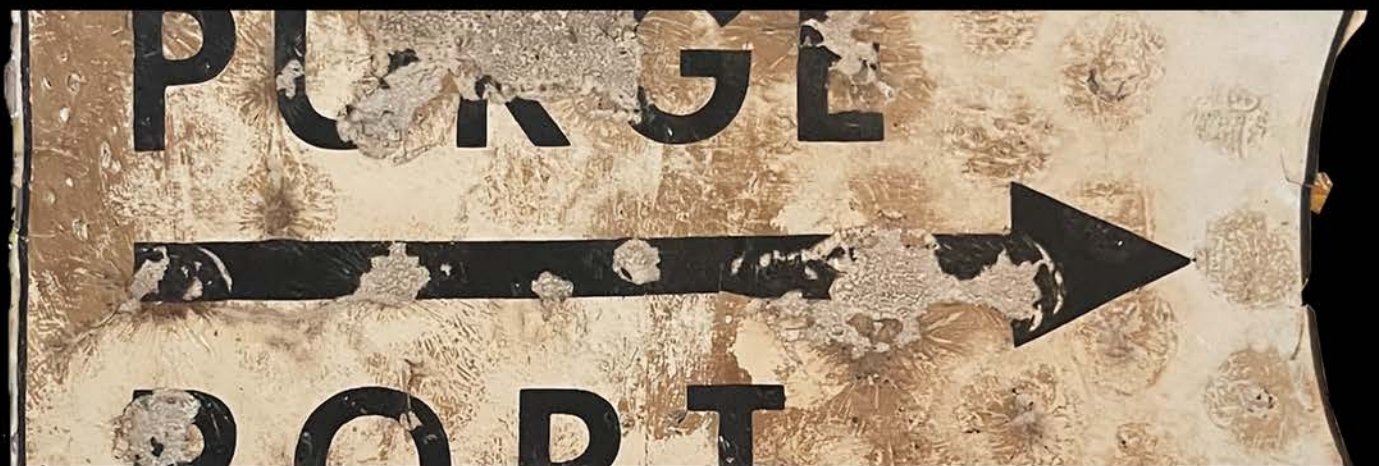
2.2. *(Below) Apollo 16 Purge Port decal with hexagonal imprint from the Command Module hatch door visible through re-entry scorch marks.*

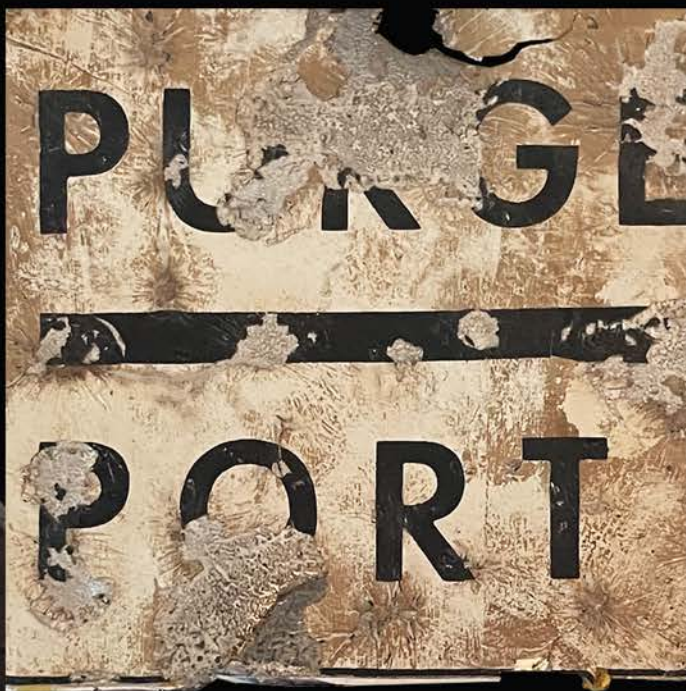
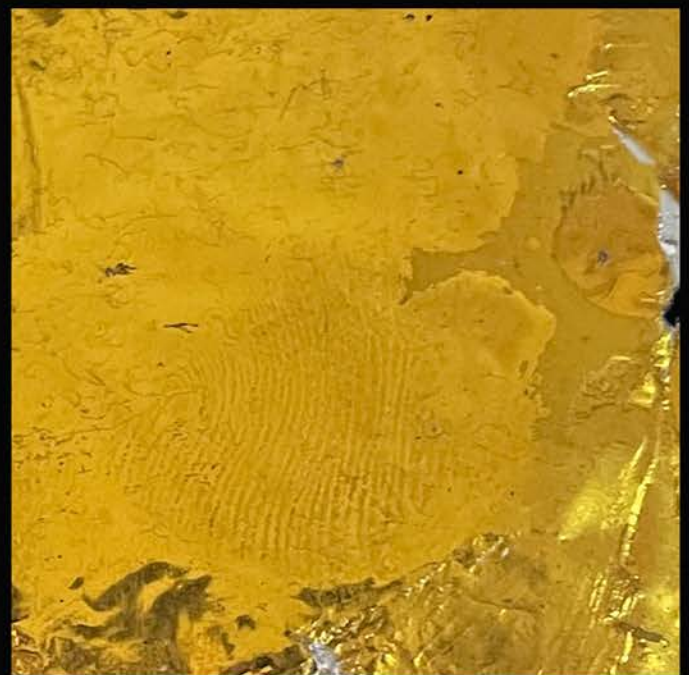
3.1. (Left) Close-up view of the "PURGE/PORT" section of the Apollo 16 Purge Port decal. (Right) Close-up view of the kapton foil underlayer.

The Command Module was coated in layers of reflective mylar foil, often referred to as kapton foil, with one side gold and the other silver. It is a common misconception that the gold side of the foil faced out into space when in actual fact, it was the other way around; the silver side was exposed to outer space, with the gold side being adhered to the outer shell of the Command Module. This belief is brought about by photographs of the Command Module in orbit around Earth and appearing gold in color. This gold color was due to the light reflected off the Sun, which gives the impression that the Command Module was coated in gold foil as opposed to silver.

The Unlock/Unlatch decal comprises the original underlayer of kapton foil as was attached to the Command Module and topped by a separate layer bearing the decal. The gold side of the foil faces away from the decal as expected, with the silver side visible in the "URG" and "PO" text area as a result of damage from the extreme heat of re-entry.
